2011 Annual Inspection Report

Barataria Bay Waterway West Bank Protection

State Project Number BA-23
Priority Project List 4

June 23, 2011
Jefferson Parish

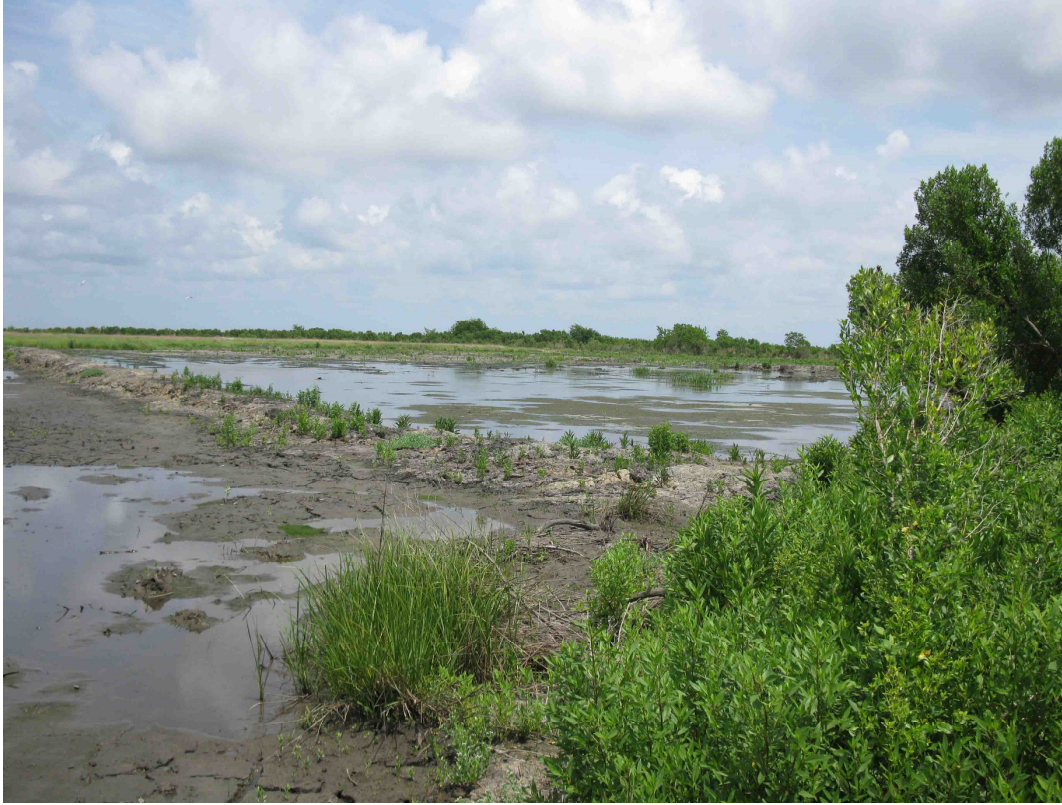
The structure was opened for the first time since the oil spill on March 23, 2011. Everything is still in good condition. Some of the stop logs need repairs and the slots need to be cleaned, but no major repairs are required at this time. The landowner has informed me that the test well that was drilled was successful and a more permanent structure will be placed at the mouth of the canal, to one side. The access dredging they did disturbed little of the 2007 maintenance marsh creation inside the channel. The marsh that their dredging created within the project appears to be a little low in spots but overall looks good (Photo #1).

Photo #1 – Well Dredge Marsh Creation

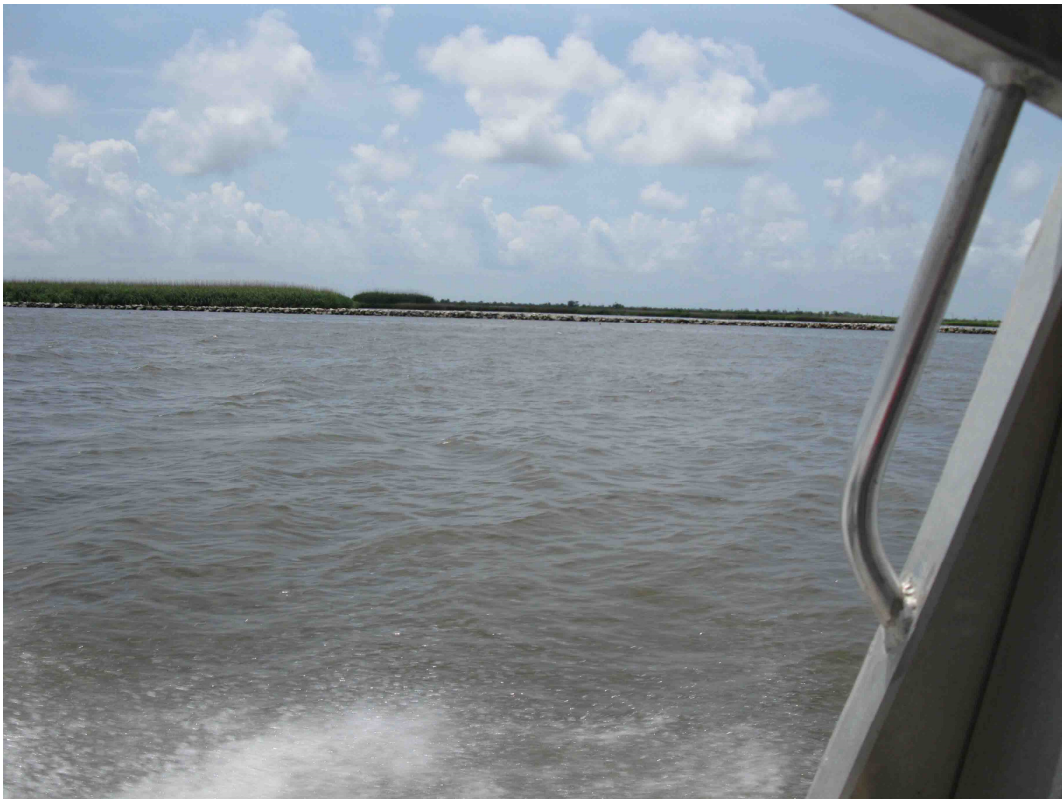
The rock structure appeared to be in good condition at the time of the inspection (Photo #2). There are some sections of settlement, but the structure is still functioning as designed. These sections will continue to be monitored for maintenance needs.

Photo #2 – Note low spot on left.

- Continue to check the water control structure during operational procedures.
- Continue to observe rock structure for settlement.
